Cyclic Fatigue Durability of uncoated and EBC coated 3D SiC/SiC Composites under thermal gradient conditions at 2700F in air

Craig Smith, Bryan Harder, Dongming Zhu
NASA Glenn Research Center, Cleveland, OH

Examination of Sample that Broke During 487 Hour Thermal Gradient SPLCF

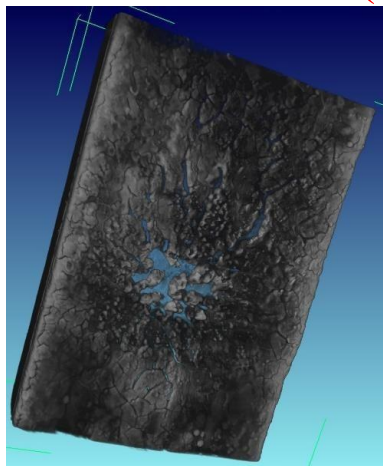
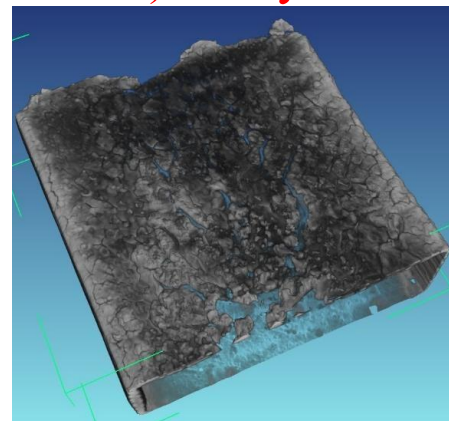
After Laser SPLCF (69 MPa, 487 hr)- Only EBC Shown

- Thermal gradient tests are relevant for cooled CMCs
- Interpretation of the data is complicated
- CT images of as-produced sample showed regions of thin coatings
- After the 487 hour SPLCF, some areas of the coating were missing
- The sample may have been overheated beyond 3000F (EBC temperature)
- This sample lasted 487 hours under thermal gradient SPLCF
- More tests are underway to evaluate the material
 - Steam exposure, more thermal gradient tests

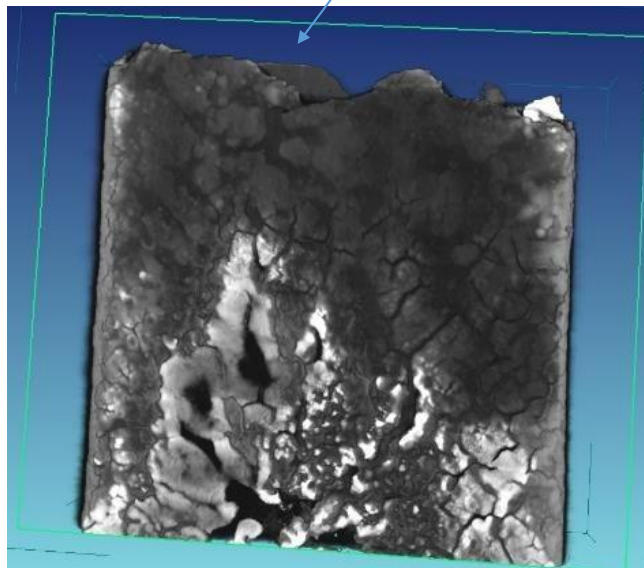
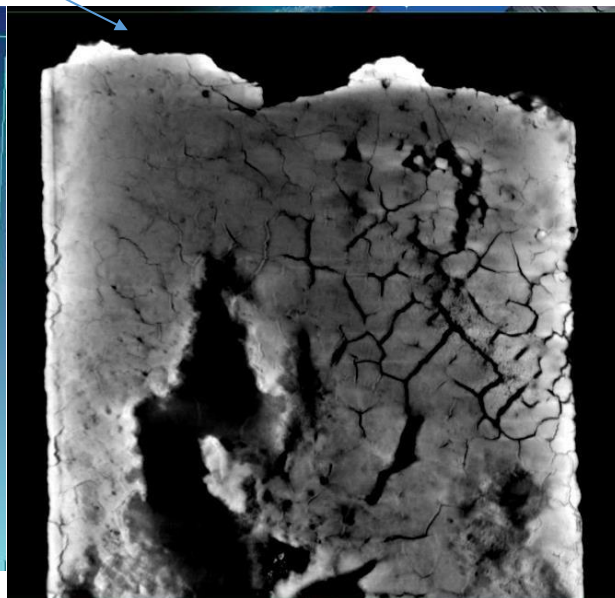
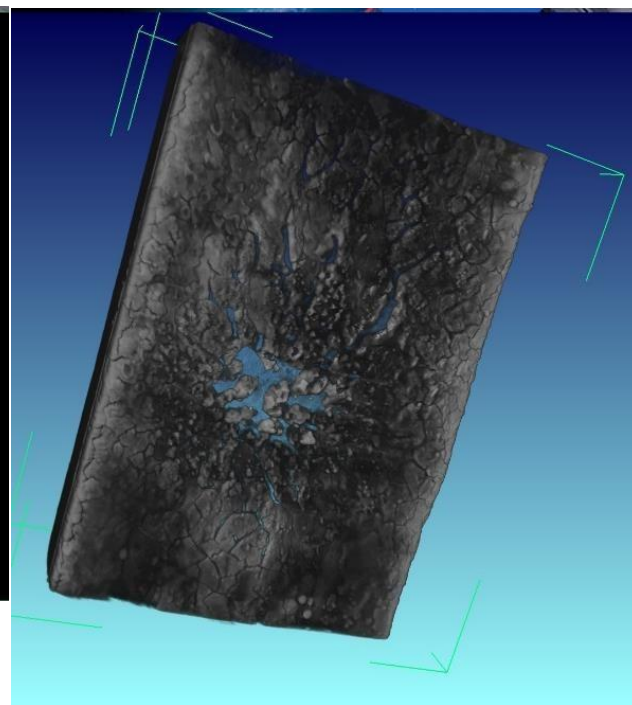
CT Images After Thermal Gradient SPLCF

Fractured End

Image of the EBC Only

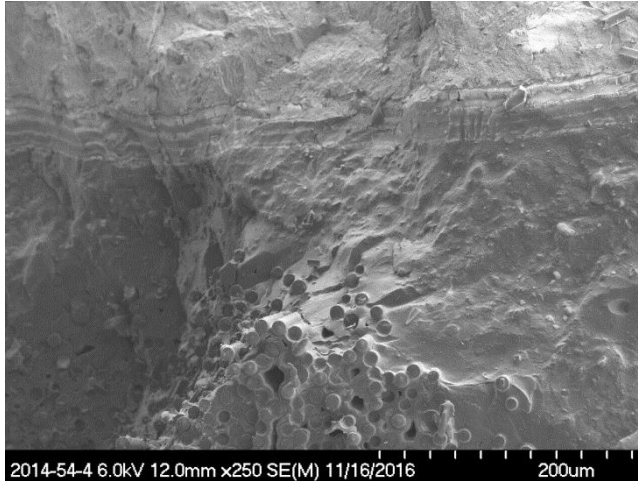
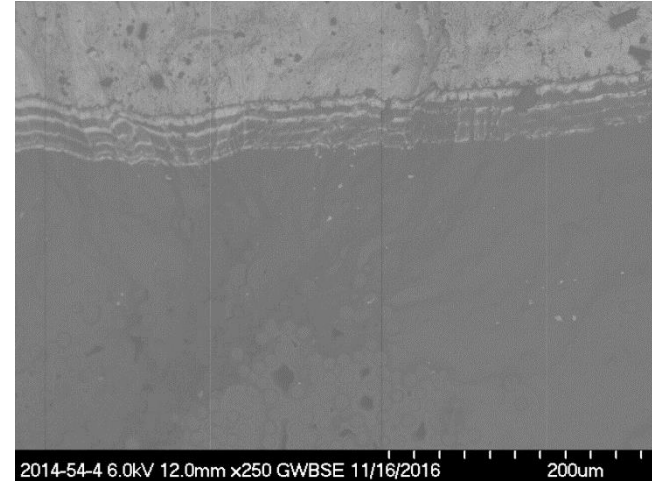
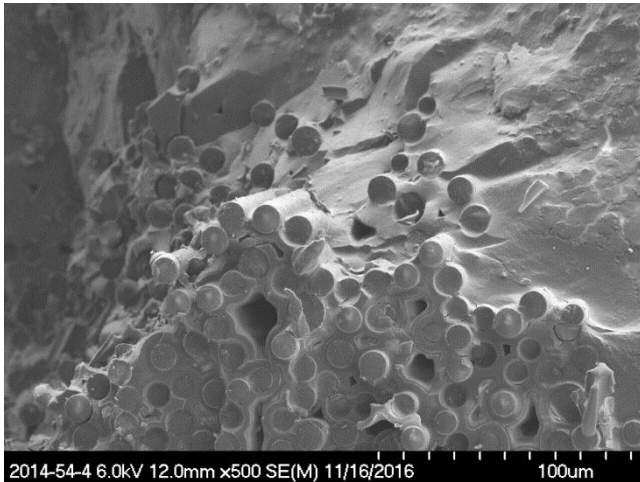
SEM of Fracture Surface after 487 hour Laser SPLCF

- Most of the fiber tows exhibited brittle failure
- Oxygen mapping of the cross-section was planned, but not yet completed
 - We want to know if the bond coat is oxidizing in air, before moving on to steam
 - Regardless, the sample lasted 487 hours
